The Restoration Project of the HAR RAJ JI KA MAHAL, Jaisalmer Fort, Rajasthan, India, has been under progress for over the past three years. After a systematic preparation of Tender Documents, and subsequent award of the contract, on-site work formally commenced in January 2003.

The present Report is an endeavor to summarize the entire description of works that has been undertaken till date on the Har Raj Ji ka Mahal site under the purview of the Restoration Project in Phase II.

PHASE - 2

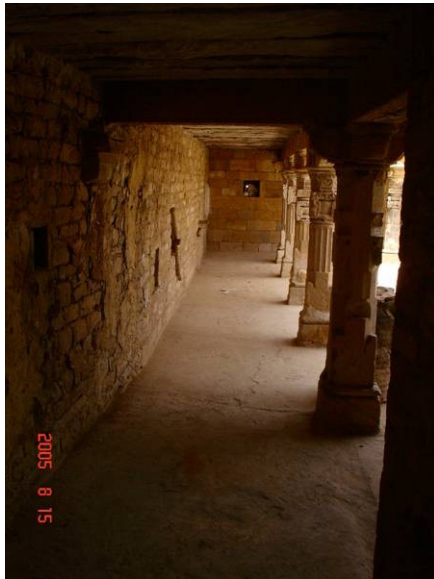
Completed Portion of L section –
Section A - Second Floor

Ornamented columns in pillared courtyard on second floor have also been erected at original positions. The L-section in Second floor has been completed with floor finishing and stone slab roofing.

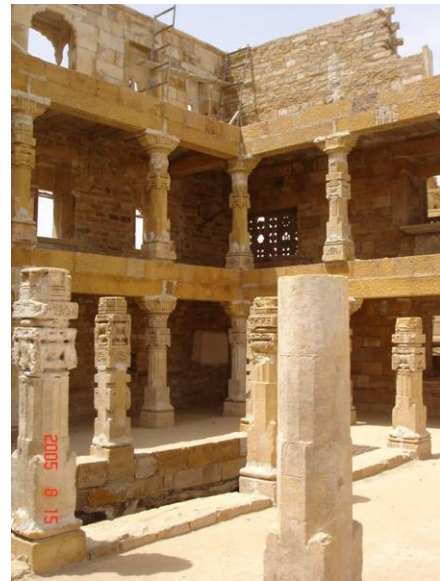
View of pillared court showing
second & third floor

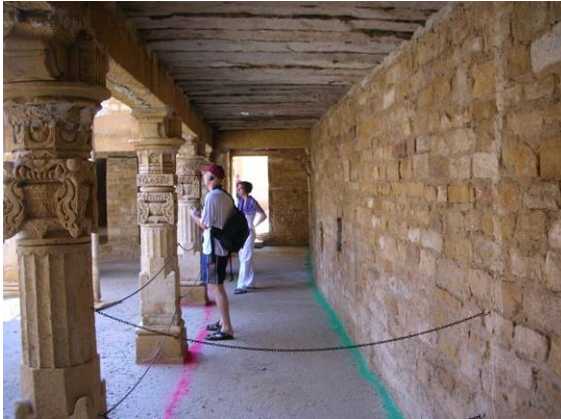
Completed Portion of L section – Section A
Jharokha has been restored in the wall facing Chogan para street.

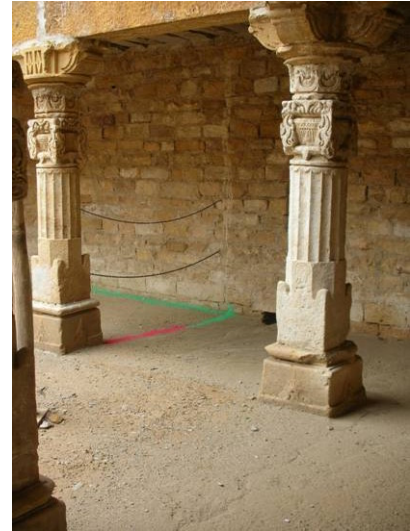
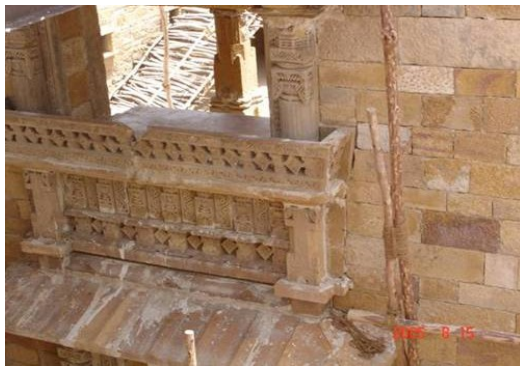
Jharokha facing Chogan Para Street

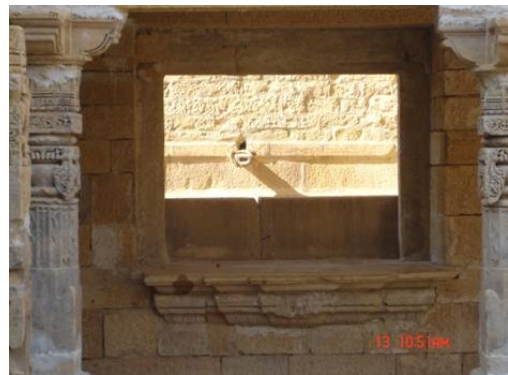
View of restored Jharokha from inside

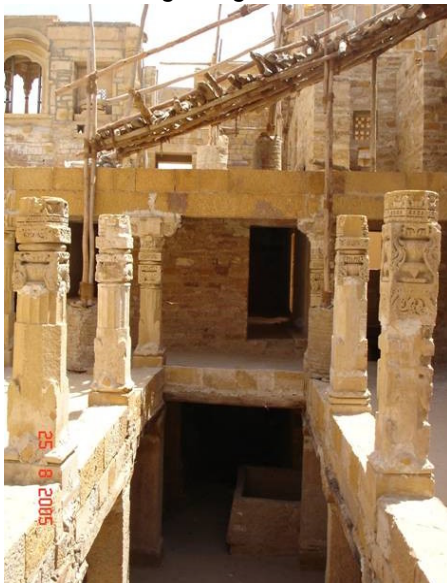
View of pillared court showing first floor below

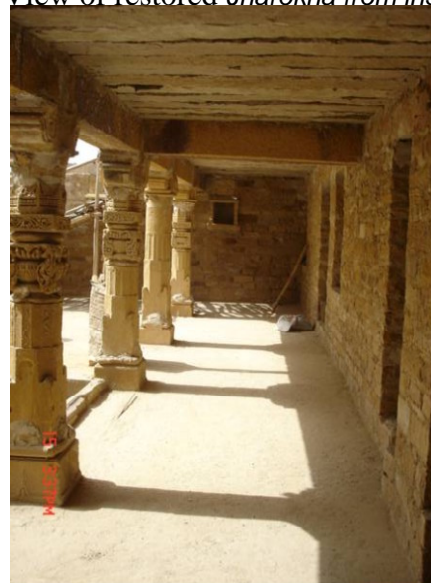
Stone slabs in Roof – Second floor

The L - section of third floor has been completed with the erection of ornamented columns in line with the columns below on second floor. Finishing of floor and reconstruction of roof with stone slabs has been completed.

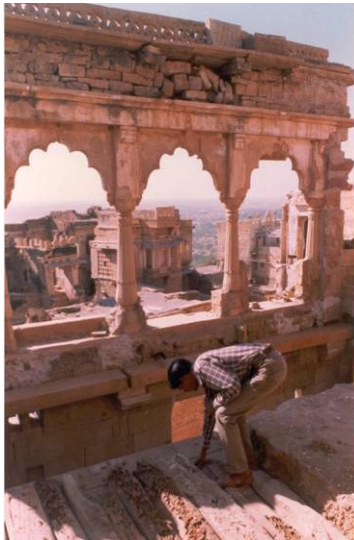
Columns and Arches on fourth floor before dismantling

The L-shaped fourth floor section has been completed. The arched walls were dismantled, and reconstructed piece by piece. The columns and arches have been completed and roof laid over it. Elevation of wall on the fourth floor has been erected such that the elevation from Dusshera Chowk gives a complete look. This floor was very intricate in design having decorative elements like cusped arches, jharohas and stone panel wall. Every element has been carefully restored to its original position.

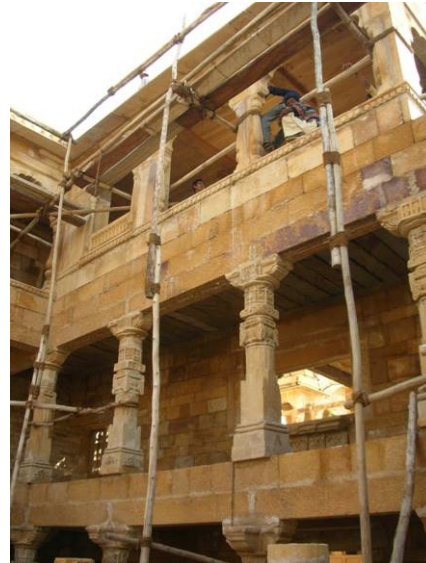
Columns and Arches after restoration

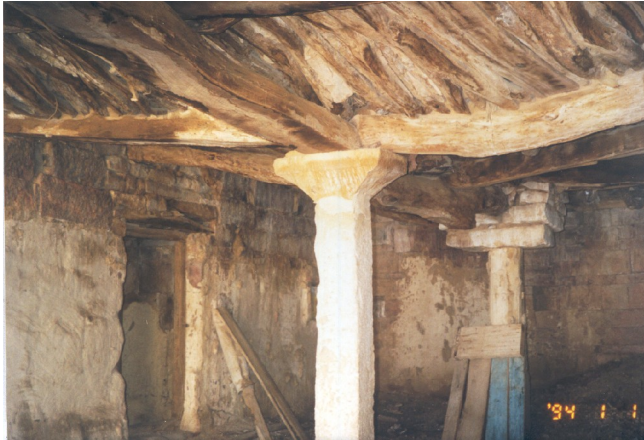
Wooden members were sagging under the load, and were badly damaged

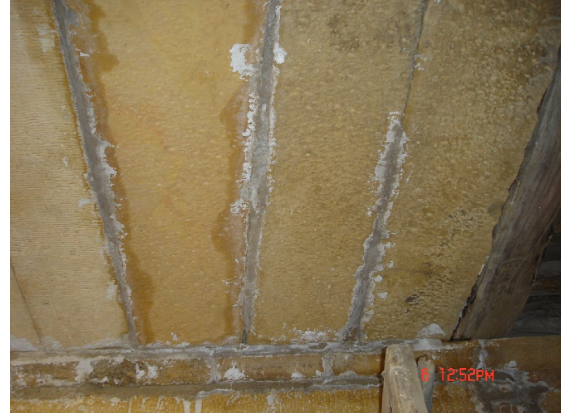
Wooden members were replaced with local Jaisalmer stone

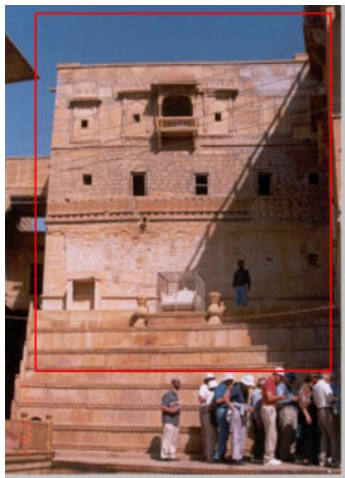
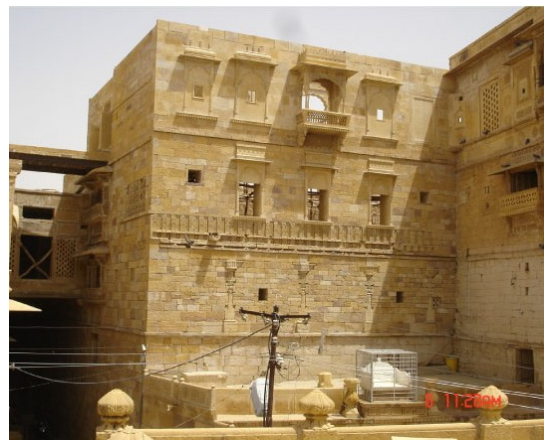
The design of the external face of the throne wall on the fourth floor has been made changed slightly from original wall design. The original wall had jharokhas on the fourth floor level, with a central window flanked by 2 smaller windows at close intervals.

On the restored wall, the windows on both floors have been placed symmetrically below one another, with larger spacing in between. As suggested by Maharawal of Jaisalmer new jharokhas have also been added on the third floor windows.

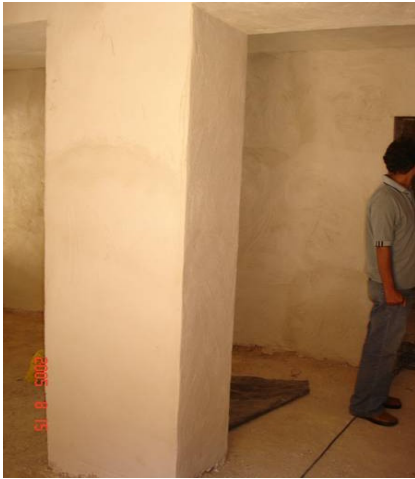
Inspection of quality of Lime paste by the Architect

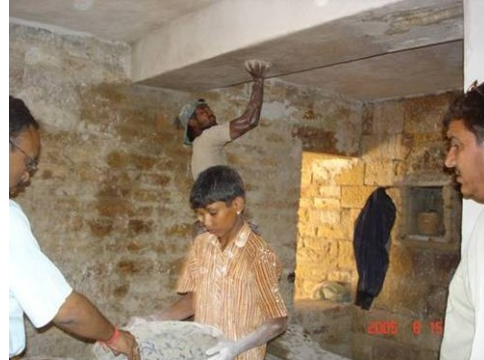
Plastered walls – second floor

The walls of the rooms in Section B on second floor have been constructed and have been plastered with lime.

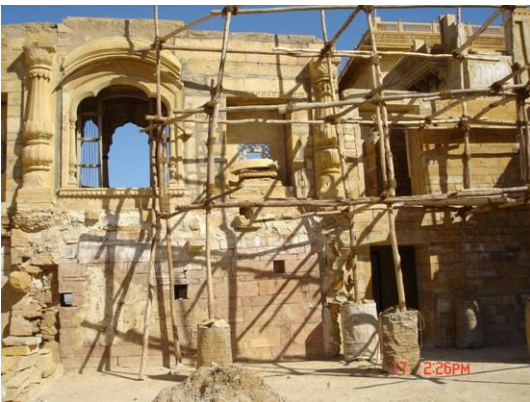
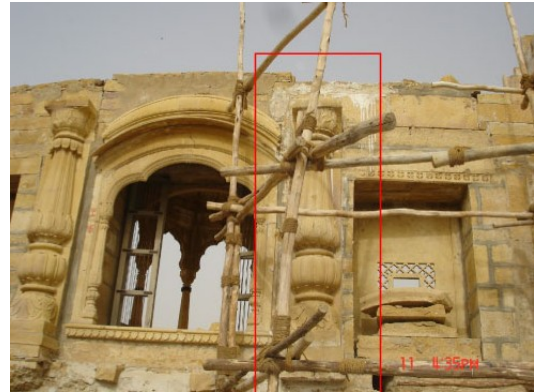
Reconstruction of Wall next to staircase

The Gokhda wall has been redesigned symmetrically and restored. All cracks have been repaired. Column on the surface of the wall with “gokhda” has been moved to a position next to the window, so as to form a symmetrical design on the wall.

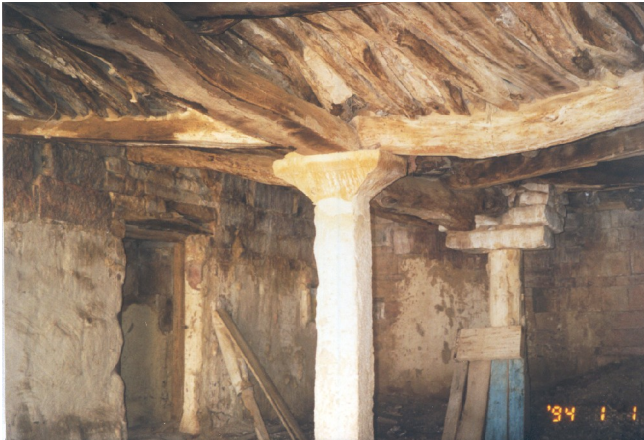
Wooden members were sagging under the load, and were badly damaged

All roof members in *chiyad* wood were replaced with local Jaisalmer stone slabs as wood was not easily available and also it requires more maintenance than stone slabs. The existing roof material was damaged and had rotted; therefore we used the more stable and long lasting Jaisalmer stone to provide support to the slab.

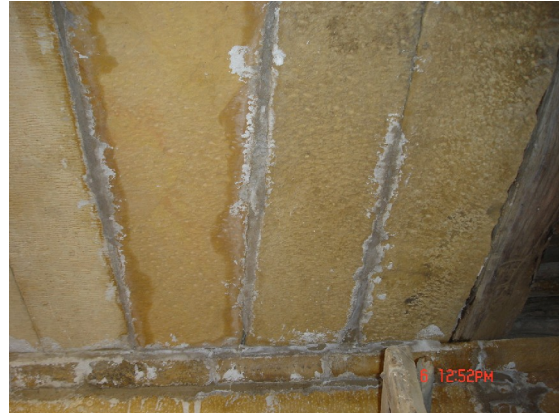
Wooden members were replaced with local Jaisalmer stone

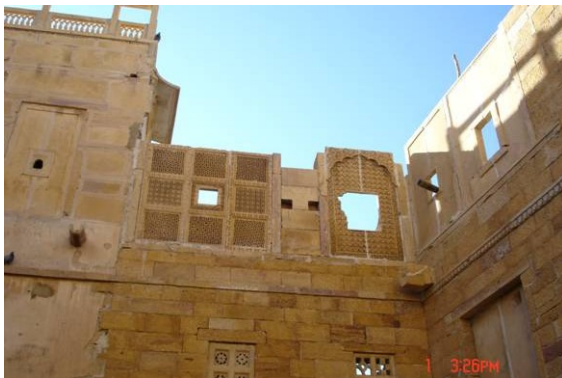
Elevation of wall facing Tamboo Khana chowk has been restored till third floor.

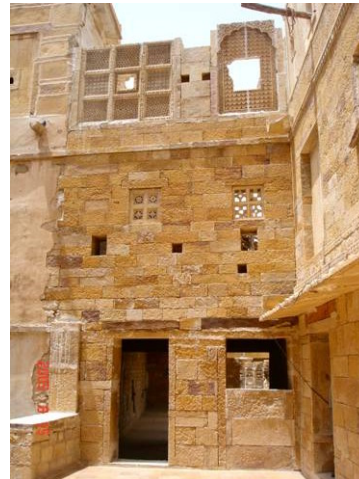
Decorative Jali work on the third floor over the Tambu Khana Chowk is being reconstructed, although the room has not been constructed as yet.

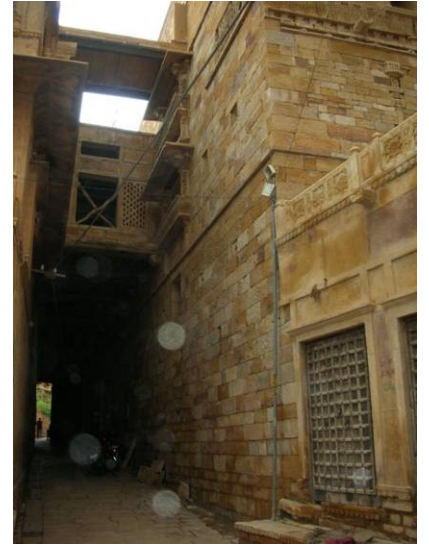
Lower and Upper bridge over Chogan Para Restored

Bridge connecting Section A and Sabha Mahal has been restored with stone slabs as per instructions. Bridge was strengthened by using iron girders. Top level connection form fourth floor to Sabha Niwas has also been restored.

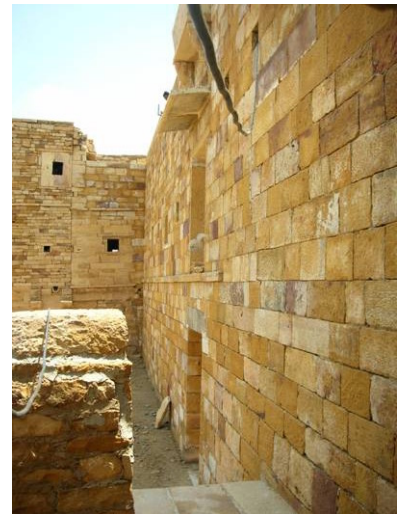
Out of Plumb Payaga wall restored with proper verticality.

Payaga wall has been completed till fourth floor. Parapet over wall is still left and will be taken up in phase III. Retrofitting has also been done in this wall as this was a free standing wall and vulnerable to lateral forces like wind pressure and earth quakes. Rcc band has been incorporated in the wall. A “chaap” at an interval of 1 mt from RCC band has been placed.

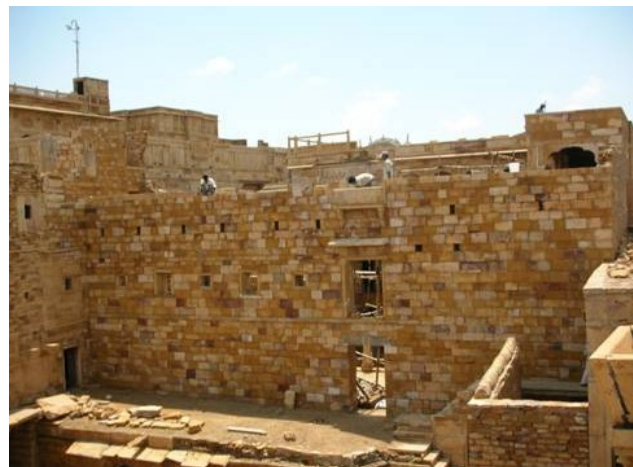
View of Payaga Wall Restored

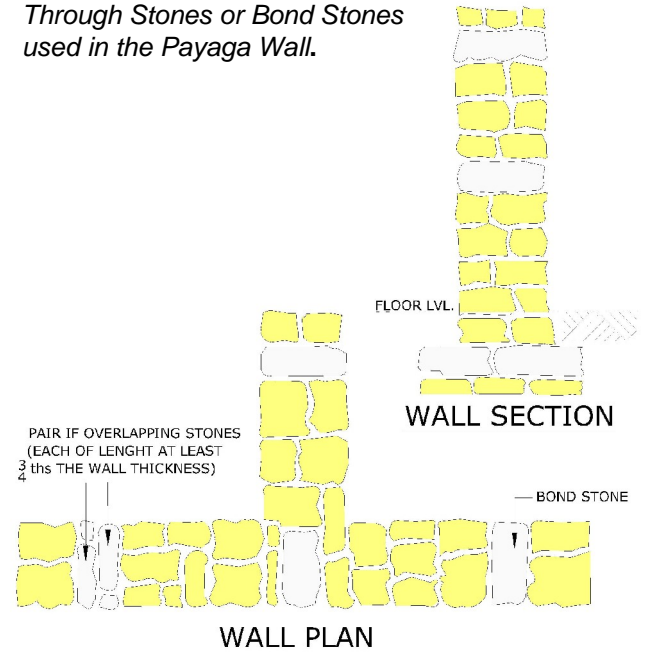
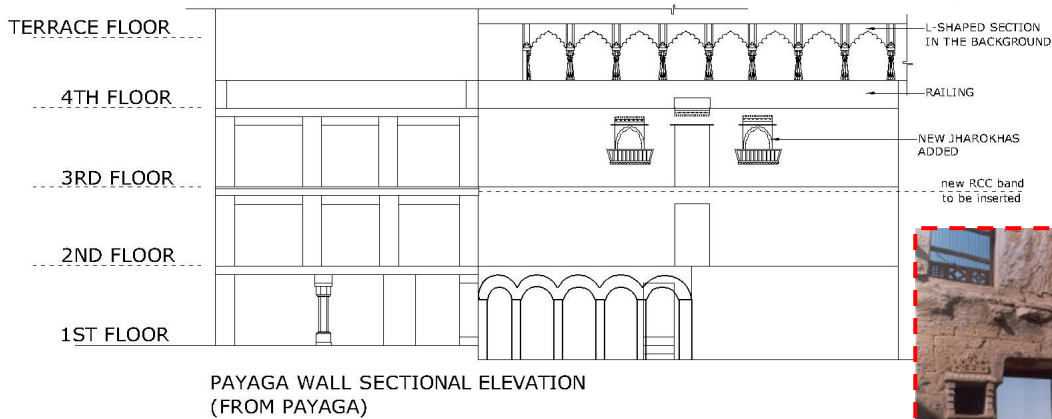
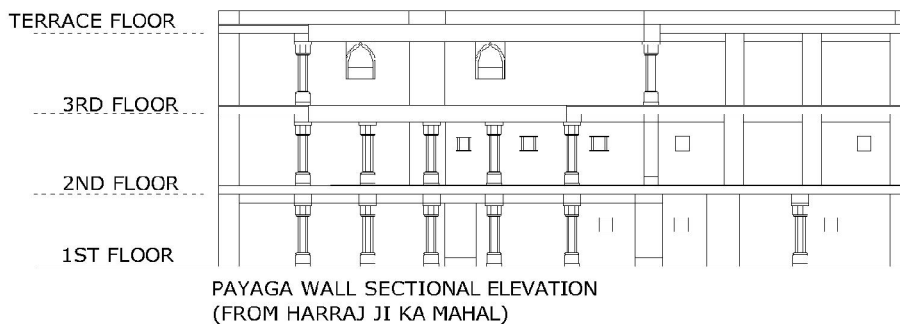
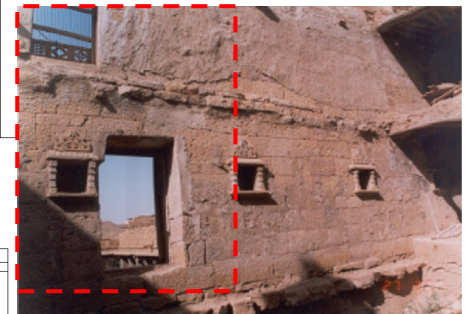
Through Stones or Bond Stones used in the Payaga Wall.

The staggered doors in the existing wall were made in one line as per drawing attached

The “through stones” or “bond stones” have been placed more frequently to strengthen the structure. This has been staggered to give earthquake resistance to the entire structure. (Refer wall plan and wall section attached)

The elevations drawings (below) of the Payaga wall show the stone arch wall on the fourth floor as it has been constructed. Few square openings have been added on the third floor. These will help the free standing Payaga wall to withstand wind pressure. The staggered doors on third and fourth floors have been straightened in the new wall.

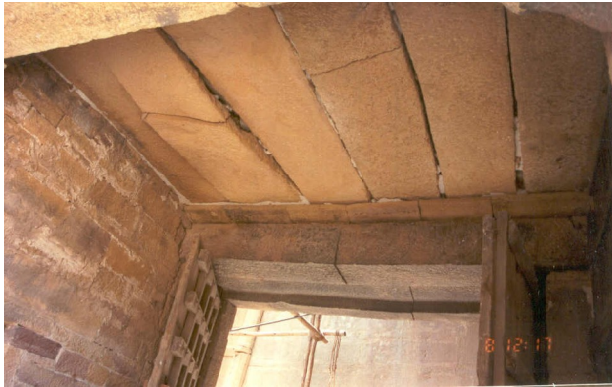
The stone slabs were broken and disjointed under the tremendous load

The gateway has been restored and rebuilt from scratch, with neat joints and level surfaces, with corrected defects and faults. The existing stone slabs were broken and sagging due to the tremendous load, which has now been rectified by replacing them with new stones and inserting girders which will take the load away from the existing stone lintel.

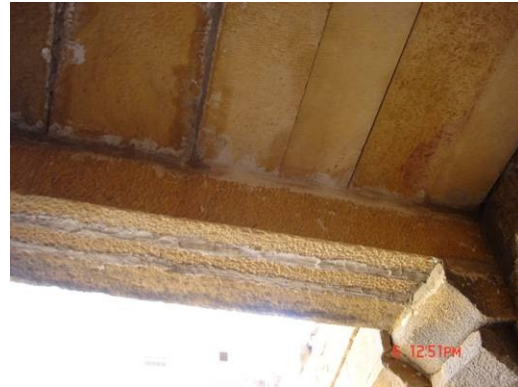
The stone slabs have been restored and neatly joined to form the gateway

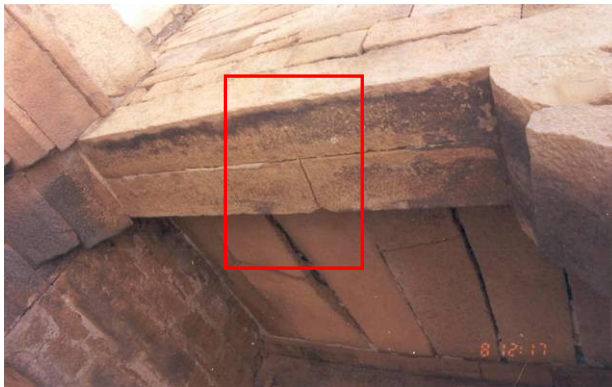
The stone slabs have been restored and neatly joined to form the gateway

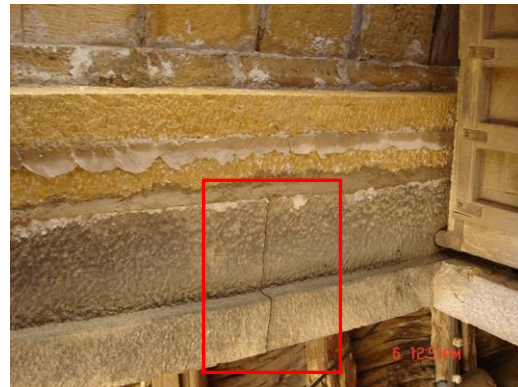
The damaged stone has been restored to reconstruct the gateway

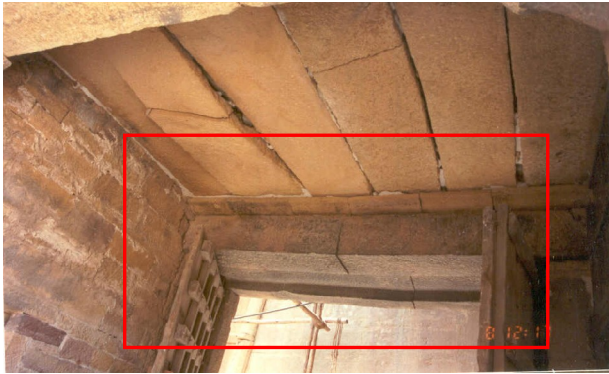
Sagging lintel and frame in the interior

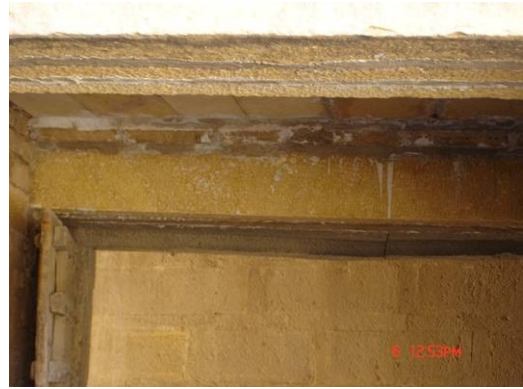
Load has been transferred by placing a new girder over the existing lintel

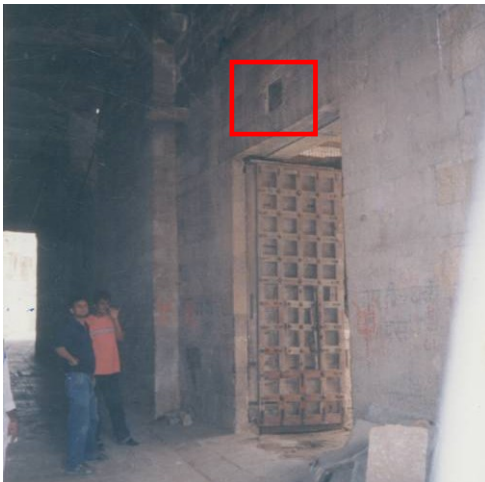
Sagging lintel and frame

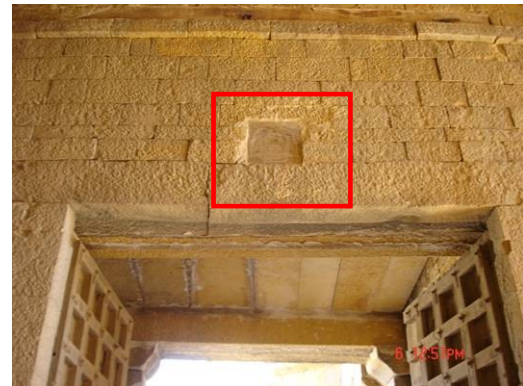
Wooden doorframe and stone lintel have been retained but reassembled, to remove faults

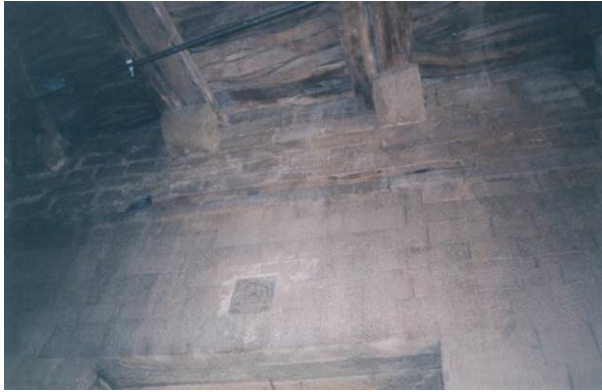
Historic carving over gateway has been replicated and placed in it's earlier location

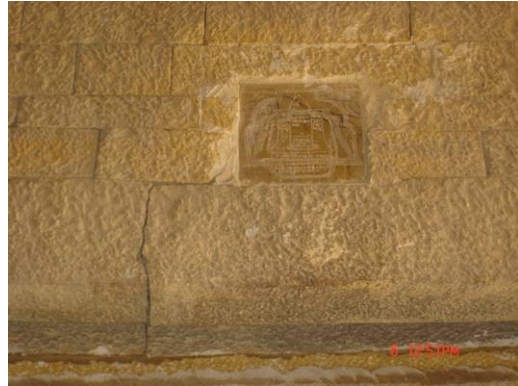
Detail of Historic carving over gateway which has been restored and retained in its original position

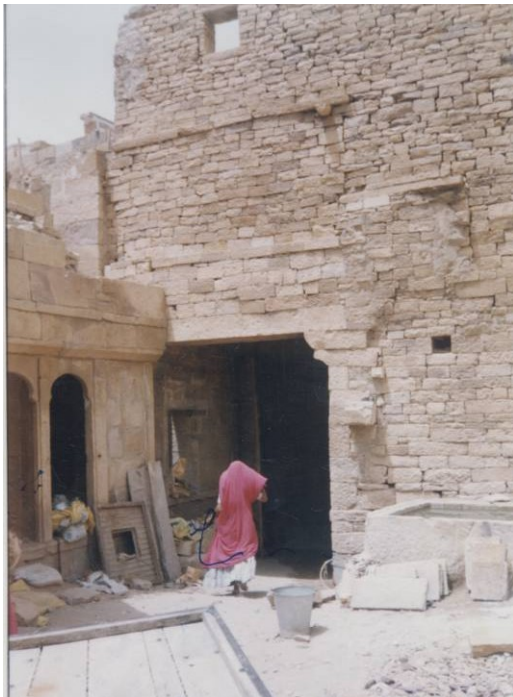
Wall over the gateway was in a dilapidated condition

Structural interventions have been made externally, providing girders to take the load off the lintels. Also, the entire external wall was dismantled piece by piece and reconstructed taking extreme caution to achieve perfect joinery and a neat wall.

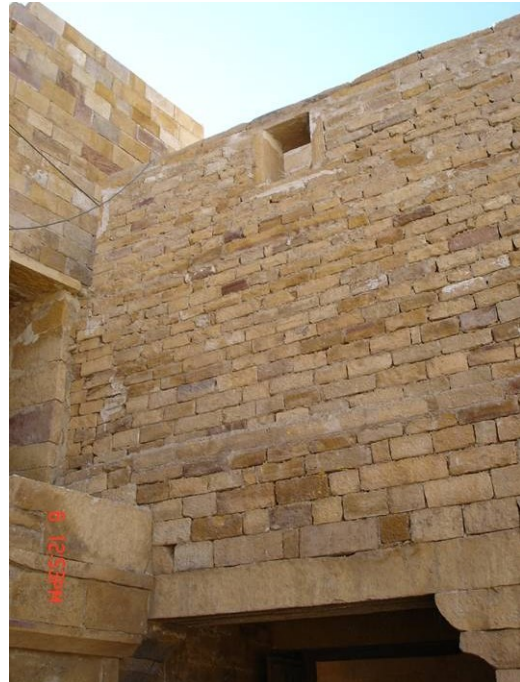
Wall over Gateway has been reconstructed after complete dismantling

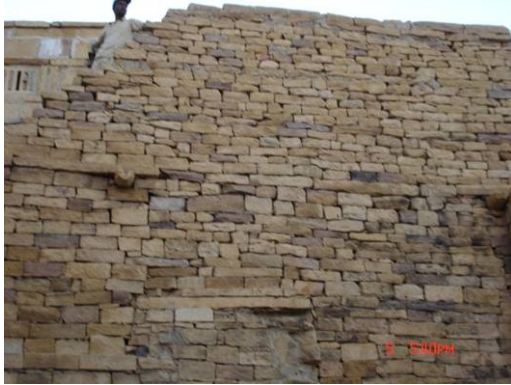
Wall over Gateway has been reconstructed after complete dismantling

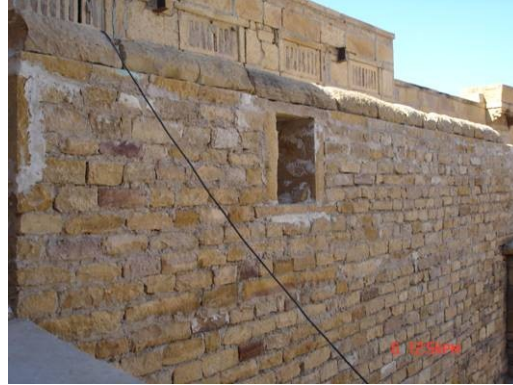
Edging of Parapet on First Floor has been done by chamfering the stone

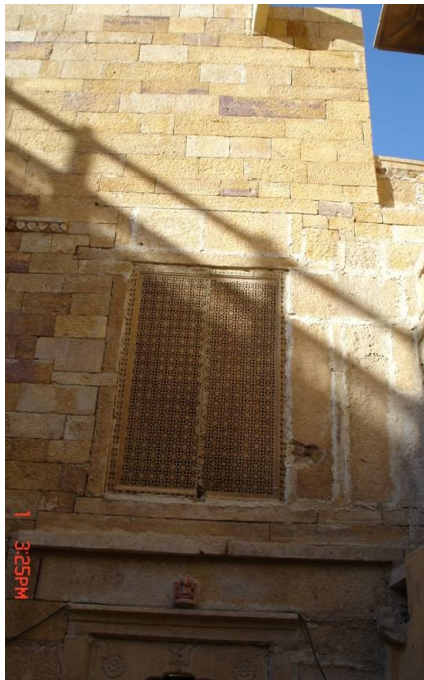
Wall above gateway to staircase

The staircase connecting the Har Raj Ji Ka Mahal and the Hawa Prol has been dismantled, restored and is functional. The load bearing wall supporting the staircase was weak and had to be reconstructed. This part was not in the scope of the project but was taken by Girdhar Smark trust as it was affecting the reopened portion of Harraj Ji ka Mahal.
